Oregon Independent Aggregate Association Newsletter

April 2025

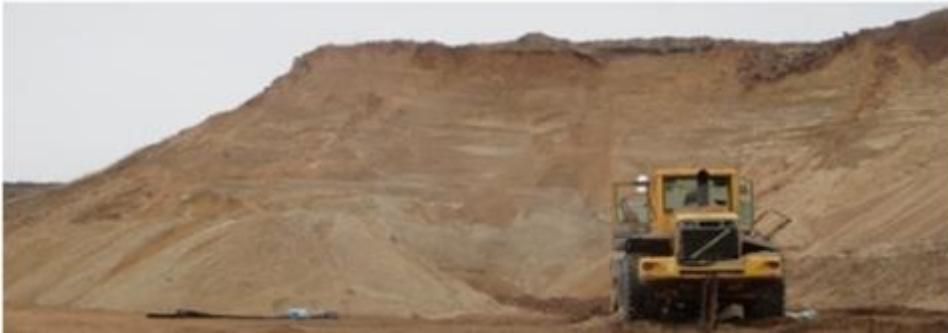
MINE FATALITY – On **March 28, 2025**, a miner was fatally injured at a surface mine when sand from the highwall engulfed the front-end loader he was operating. The miner was digging sand from the toe of the highwall.

This is the 11th fatality reported in 2025, and the fifth classified as “Powered Haulage.”

Use mining methods that ensure highwall stability and safe working conditions.

Use appropriate equipment to gradually flatten the slope starting at the top of the highwall.

Equip front-end loaders with two-way communication systems, high strength glass, and an SCSR for breathable air when working on material that has the potential to slide or engulf mobile equipment.

Examine highwalls, spoil banks, and ground that slope into working areas. Correct unsafe ground conditions in the affected area. Conduct additional examinations as ground conditions warrant, especially during periods of changing weather conditions.

Stay clear of potentially unstable areas.

Establish and discuss safe work procedures before beginning work. Identify and control all hazards associated with the work and the methods to properly protect miners.

Train miners to assess risks and hazards and correct or barricade hazards to prevent access before beginning work activities.

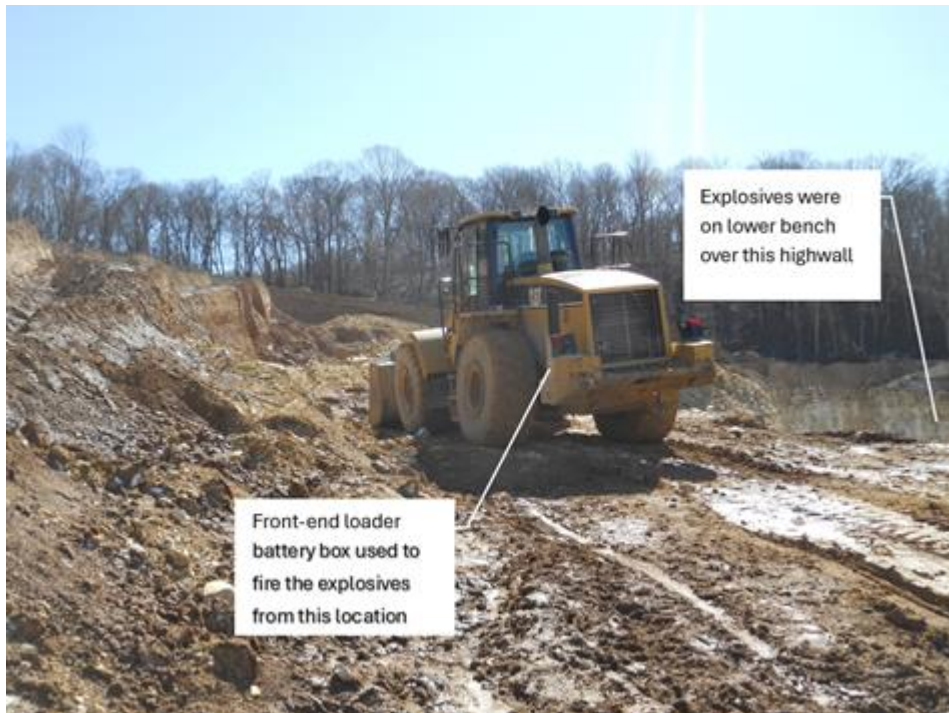
MINE FATALITY – On **March 5, 2025**, a miner was fatally injured at a surface mine when flyrock from blasting operations struck him. The miner was assisting in detonating the explosives.

This is the tenth fatality reported in 2025, and the first classified as “Explosives and Breaking Agents.”

Remove all persons from the blast area unless using suitable blasting shelters to protect persons from flyrock. Wait at least 15 seconds after the blast for any flyrock to drop and settle before exiting the shelter.

Adjust stemming depth and/or decking to maintain adequate burden on all sections of the blast hole. Consider geology, face geometry, and surface topography when developing a drill pattern.

Determine the actual burden for all face holes along their length and adjust the explosive power factor along the borehole accordingly.

Only use approved capacitor discharge or generator blasting machines.

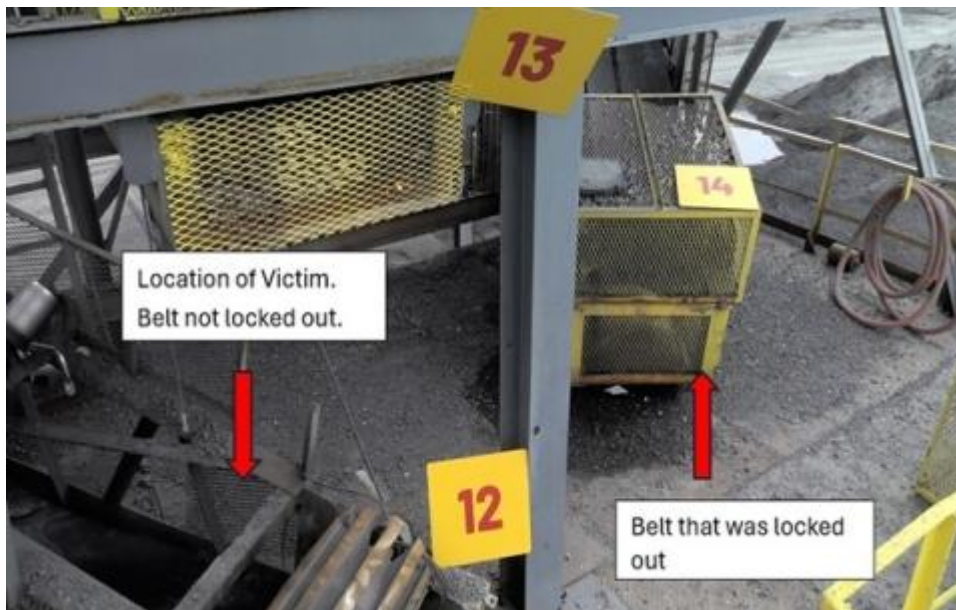
March 5, 2025, a miner died while clearing strips of old belt rubber from a belt conveyor tail roller. During this process, the belt conveyor started to operate, causing the miner to become entangled in between the fluted tail roller and the belt.

This is the ninth fatality reported in 2025, and the fourth classified as “Powered Haulage.”

De-energize, lock out, tag out, and block belt conveyors against hazardous motion before performing repairs or maintenance.

Provide safe access where miners work.

Install adequate guarding to prevent any contact between miners and moving parts of a belt conveyor, including rollers and head and tail areas.

Establish policies and procedures for conducting maintenance on belt conveyors.

Task train miners on safe work practices.

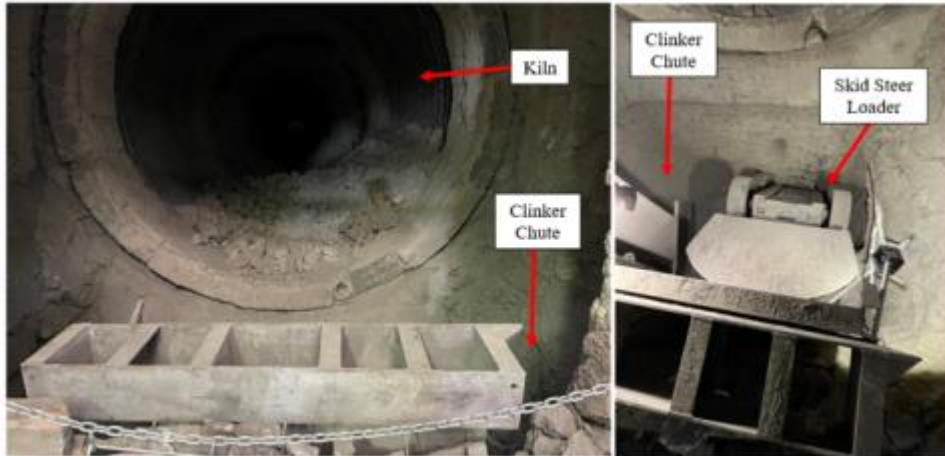
MINE FATALITY – On **February 22, 2025**, a contractor died when the bridge providing access into the kiln shifted, causing the skid steer loader he was operating to fall backwards into the clinker chute.

This is the seventh fatality reported in 2025, and the third classified as "Powered Haulage."

Provide safe access to all working areas.

Follow the manufacturer's installation instructions for bridges and ramps.

Routinely examine metal structures for indications of structural weakness (corrosion, fatigue cracks, bent/buckling beams, braces or columns, loose/missing connectors, broken welds, etc.).

Train miners on their assigned tasks, including how to identify, report, and correct hazards.

Examine work areas at the beginning and throughout the day for changing conditions that may affect safety.

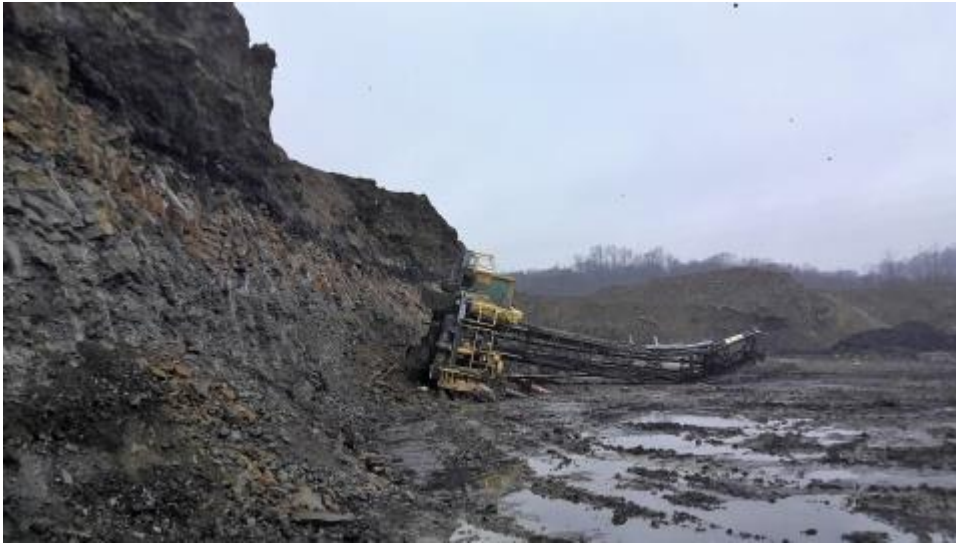
MINE FATALITY – On **February 12, 2025**, a miner died when the ground beneath the drilling rig he was operating failed, causing it to overturn and fall off the highwall.

This is the sixth fatality reported in 2025, and the second classified as “Machinery.”

Examine highwalls and correct hazardous conditions before beginning work and as ground conditions warrant.

Be aware of changes from the freeze and thaw cycles affecting the condition of the highwall.

Operate mobile drills perpendicular to the edge of the highwall.

Monitor work activities to ensure miners follow safe work procedures.

Train equipment operators to identify hazardous highwall conditions.

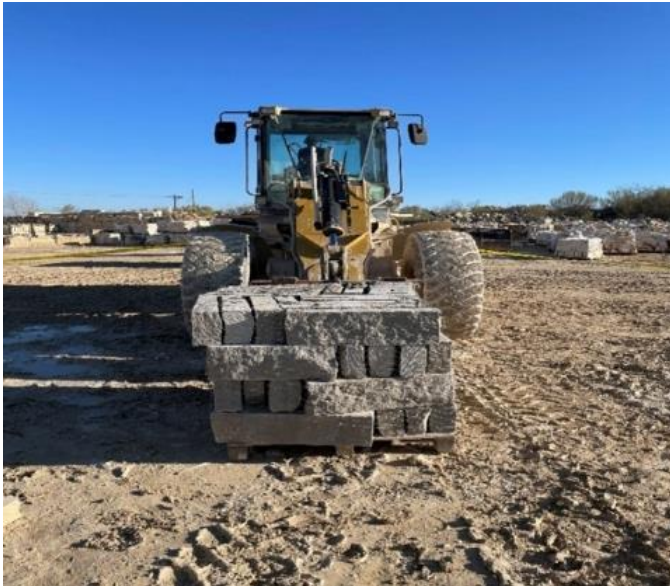
MINE FATALITY – On **January 30, 2025**, a miner died when a front-end loader operator unknowingly lowered a pallet of stone onto him.

This is the fifth fatality reported in 2025, and the second classified as “Powered Haulage.”

Develop traffic rules for mobile equipment and miners on foot. Ensure the Safety Program for Surface Mobile Equipment includes actions taken to identify hazards and risks to reduce fatalities.

Install collision warning technologies and added safety features such as cameras, sensors and radar.

Ensure adequate clearance and visibility when operating mobile equipment and be aware of where all persons on foot are located.

Wear high visibility clothing and communicate your location and intended movements to mobile equipment operators. Ensure they acknowledge your presence before you travel near mobile equipment.

Train all persons to recognize the limited visibility and blind areas inherent to the operation of self-propelled mobile equipment.

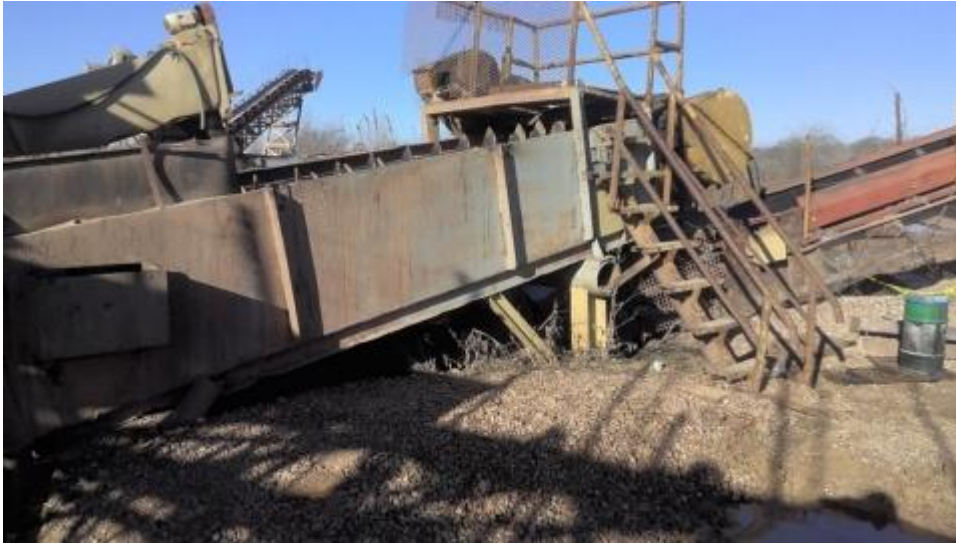
MINE FATALITY – On **January 30, 2025**, a miner died when he became entangled in a log washer. The victim was starting the log washer when he lost his balance and fell into the log washer.

This is the fourth fatality reported in 2025, and the first classified as “Machinery.”

Ensure equipment and safety devices are maintained in safe working condition.

Ensure miners are clear and free from hazards when starting equipment and performing tasks.

Always use fall protection equipment, safety belts and lines or personnel lifts when working at heights and near openings where there is a danger of falling.

Lock Out and Tag Out machinery against hazardous motion.

Maintain equipment in accordance with manufacturer's means to care for and service equipment.

Train miners in the recognition of hazards and safe work procedures.

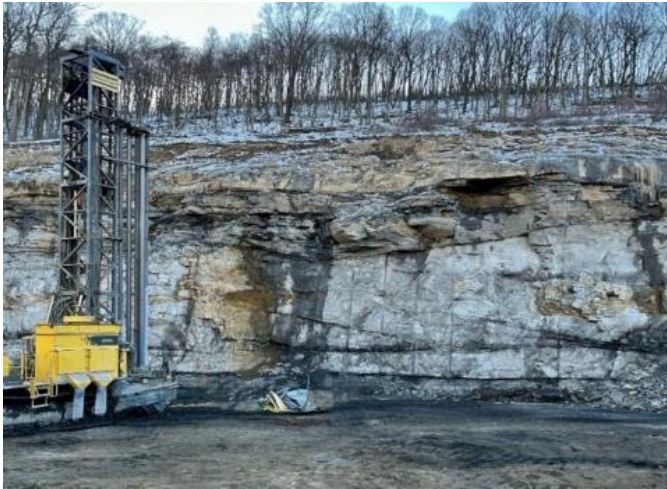
MINE FATALITY – On **January 29, 2025**, a miner died when a piece of rock fell from the highwall and struck the cab of the drill he was operating.

This is the third fatality reported in 2025, and the first classified as “Fall of Face, Rib, Side or Highwall.”

Scale highwalls from a safe location to eliminate hazards such as loose, unconsolidated rocks and overhangs.

Conduct highwall examinations prior to working or traveling near the highwall and more frequently as ground conditions warrant, especially after periods of rain, freezing, and thawing.

Examine highwalls from multiple perspectives (bottom, sides, and top/crest) and look for signs of cracking and other geologic features that could lead to instability.

Use auxiliary lighting during low light conditions to conduct highwall examinations and illuminate active work areas.

Ensure miners work, travel, and operate equipment at safe distances from highwalls.

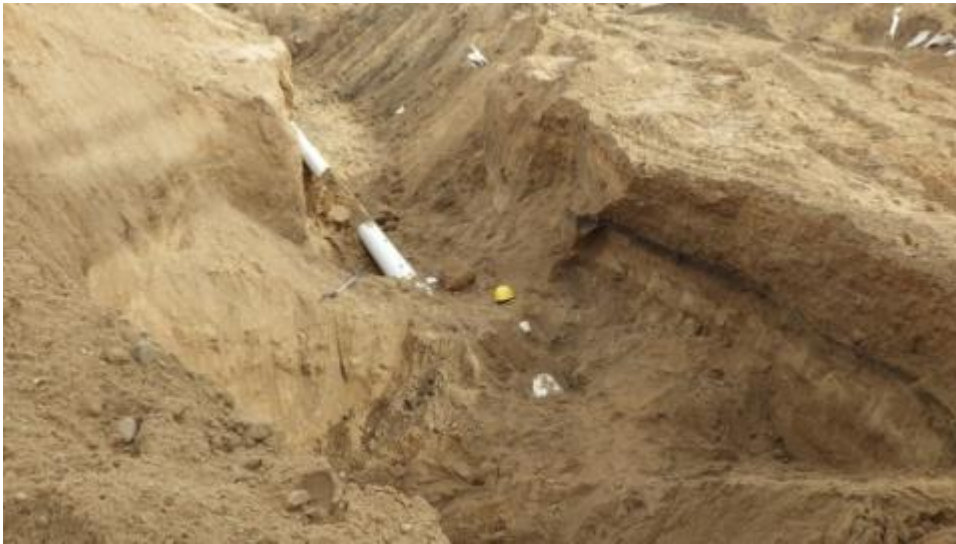
MINE FATALITY – On **January 3, 2025**, a miner died when an excavated trench collapsed and engulfed him. The victim was replacing a 12-inch discharge line in the trench when the wall collapsed.

This is the first fatality reported in 2025, and the first classified as “Falling, Rolling, or Sliding Rock / Material of Any Kind.”

Stay clear of potentially unstable areas. Do not enter trenches if the trench walls are not properly supported for the full height or sloped to a safe angle.

Establish and discuss safe work procedures before beginning work. Identify and control all hazards associated with the work to be performed and the methods to properly protect persons.

[Follow OSHA Trenching and Excavation Safety Guidelines.](#)
